ElectroSpark Deposition studies for gas turbine engine component repair

Replacement of Hard Chrome Plating
Program Review Meeting

20-21 July 2004

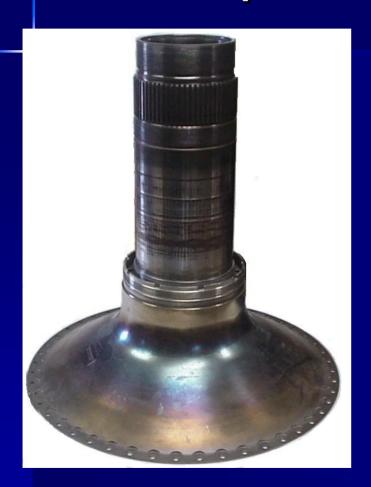
Compressor Rear Shaft

P/N 9103M58G12 TF 39 Inconel 718

The Problems:
Chrome plating on journal incomplete, surface damage

Current repair: Strip and re-plate Part value: ~ \$47,000
